New South Wales Mid North Coast flood impact and resilience research

Easterly Trough Low, May 2025

Risk Frontiers

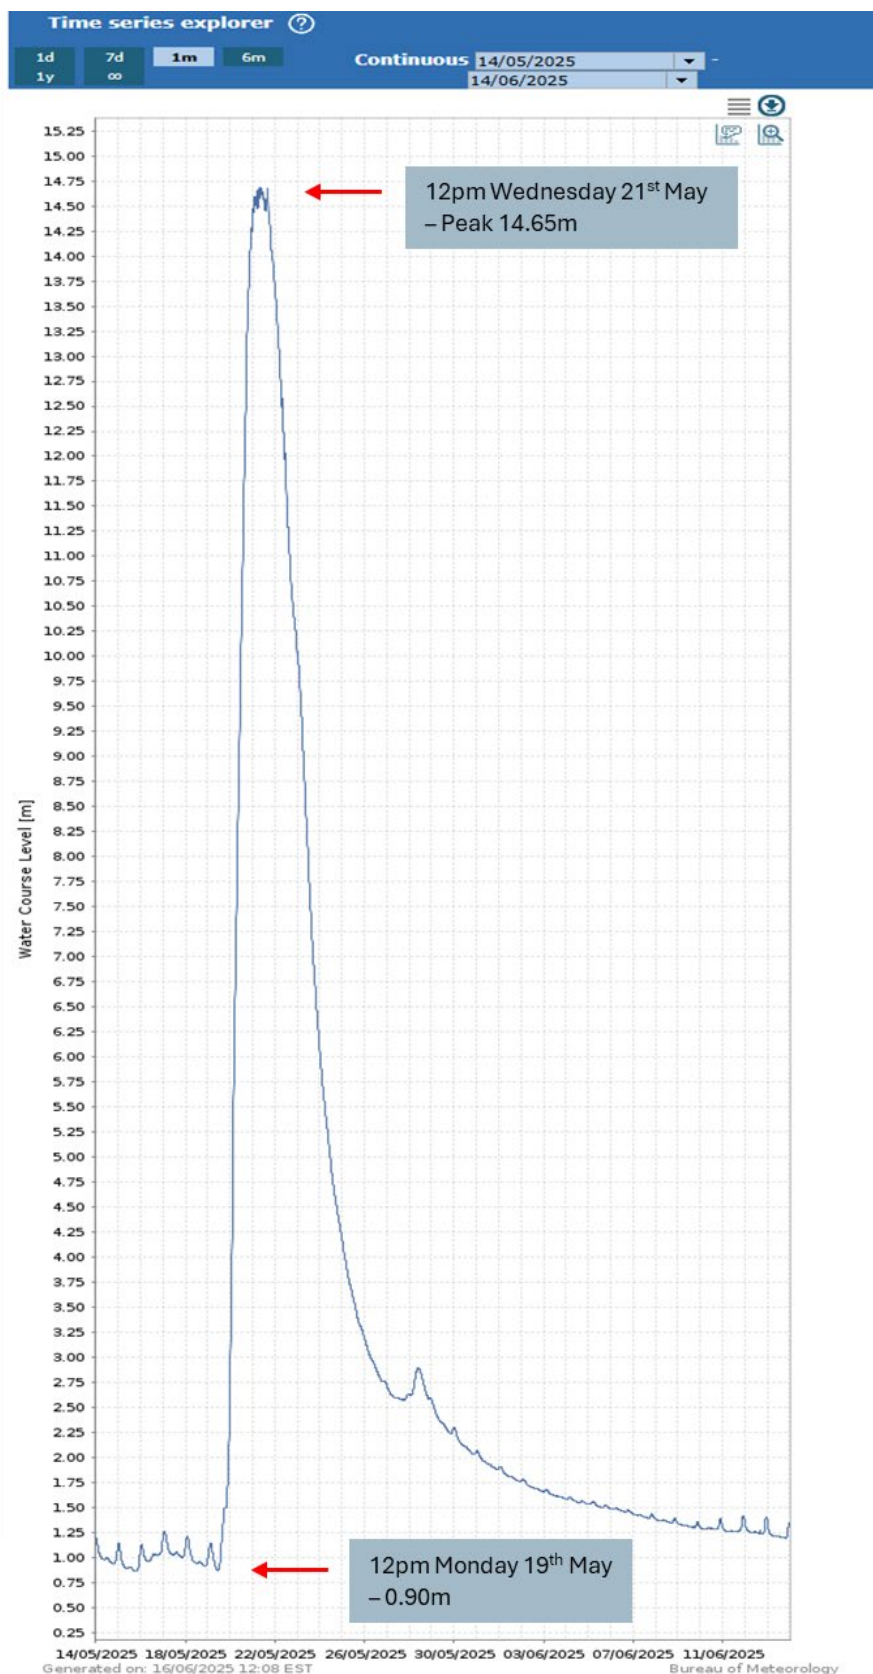
FIGURE 3 - THE MANNING RIVER FLOOD HYDROGRAPH AT WINGHAM ILLUSTRATES THE VERY RAPID WATER LEVEL RISE OF APPROXIMATELY 13 METRES OVER TWO DAYS, REFLECTING THE EXPERIENCE OF WIDELY REPORTED BY IMPACTED RESIDENTS IN DOWNSTREAM AREAS SUCH AS TAREE. (HYDROGRAPH SOURCE: BUREAU OF METEOROLOGY)

Many Taree residents observed the unusually rapid rise and subsequent fall of the Manning River during the 2025 flood event, noting that the river rose much faster than during the 2021 flood. These accounts are supported by the flood hydrograph at Wingham, which shows a rise of over 13 metres between 12 pm on Monday 19 May 2025 and 12 pm on Wednesday 21 May 2025, highlighting the speed and intensity of the event upstream (Figure 3).

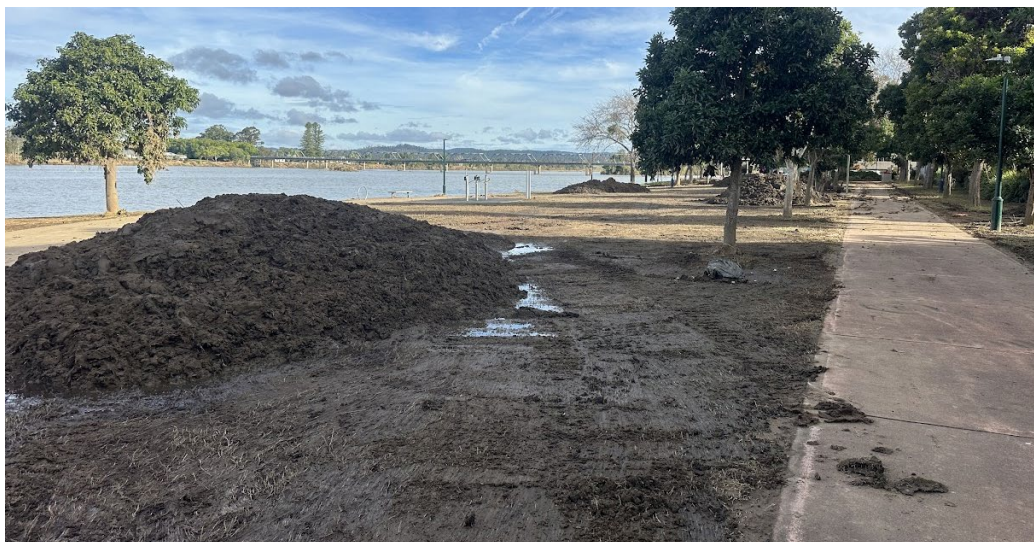
- A major concern at the time of the post-flood survey was the extensive deposition of contaminated soil and silt along the riverbank. Over 400 millimetres of sediment, carried downstream, was deposited across grassed parklands and walkways burying vegetation and disrupting public open spaces.
- Cleanup crews were actively engaged in piling the soil for removal to salvage and restore the underlying grassed areas.
- The deposited sediment was classified as 'black water contaminated', containing waste from animal sources and likely sewage, resulting in a strong, rancid odour. Due to this classification, the material was earmarked for disposal in landfill, under environmental and health safety protocols.

FIGURE 4 - CLEAN-UP EFFORTS ARE ONGOING ALONG THE NORTHERN BANK PARK AND GRASSED WALKWAY OF THE MANNING RIVER IN TAREE'S CBD, WHERE CONTAMINATED SEDIMENT, EXCEEDING 400 MILLILITRES IN SOME AREAS, IS BEING PILED FOR DISPOSAL IN AN EFFORT TO PRESERVE THE UNDERLYING GRASS.

The northern bank of the Manning River (Figure 4), within the Taree CBD, experienced severe flooding during the 2025 event, with water levels recorded at least 1.2 metres higher than those in the 2021 flood. This significant rise in flood height contributed to extensive environmental and infrastructure impacts.

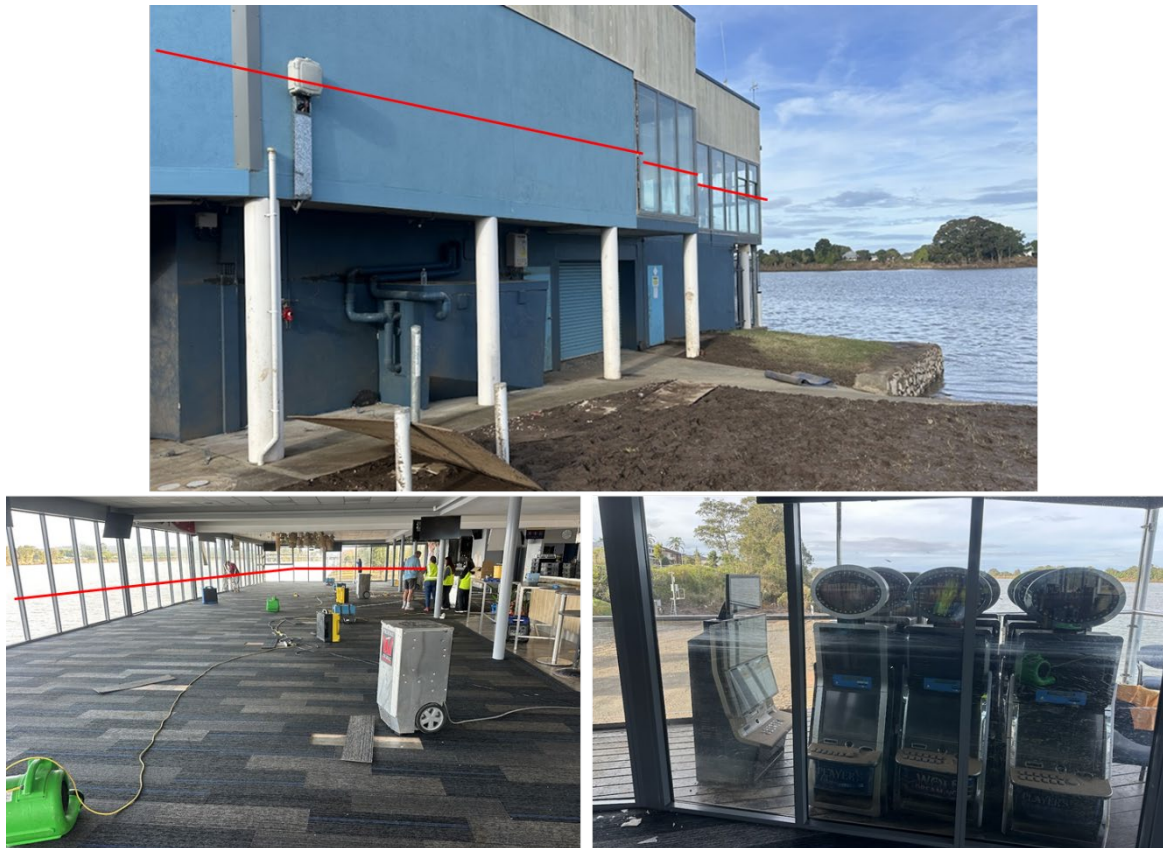
- The damage to the facility is extensive, with an estimated financial loss of at least \$1.5 million. This includes:
 - the complete loss of 37 poker machines (Figure 5(b))

- destruction of a large industrial kitchen left in place under the assumption it was safe
 - loss of all tables, chairs, soft furnishings and partial damage to flooring, though carpets are being salvaged.

FIGURE 5 - CLOCKWISE FROM TOP) (A) THE CLUB AND HOSPITALITY VENUE ON THE NORTHERN BANK OF THE MANNING RIVER IN THE TAREE CBD (LOOKING AT THE GLENTHORNE BANK) SHOWING THE PEAK HEIGHT OF THE FLOOD ON (RED LINE ON EXTERIOR OF THE BUILDING) WEDNESDAY 21 MAY, (B) SOME OF THE 37 POKER MACHINES (VALUED AT \$1.37 MILLION IN LOSSES) THOUGHT TO BE SAFE OF THE FIRST FLOOR OF THE CLUB, (C) INTERNALLY, CLUB EMPLOYEES USING FANS, ATTEMPTING TO DRY THE CARPET TILES IN THE HOPE THEY MIGHT BE SALVAGED (RED LINE INDICATES THE FLOOD WATER HEIGHTS INSIDE)

- The club commenced cleanup activities immediately following the flood, removing debris and conducting an inventory of all damaged items and placing orders for their replacement based on long delays in carrying out these activities in 2021. The club's staff were also attempting to dry out carpets using industrial fans

- The anticipated closure time is only three to four weeks; a significantly faster recovery compared to the 12-week closure after the 2021 floods. This reflects improved internal coordination, resilience of the business model and stronger post-disaster mobilisation capacity.

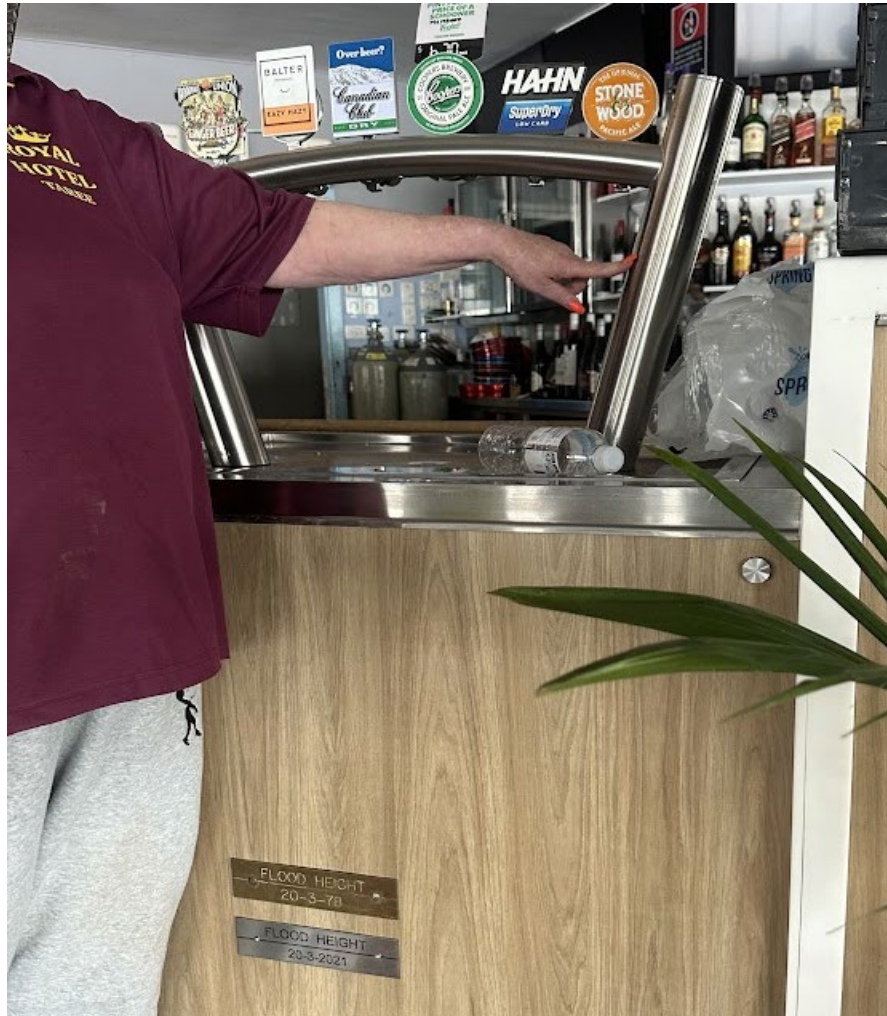
waters out of the first floor on the 2025 occasion (refer to Figure 6 - internal club flood water heights 1978 and 2021). Club employee reported that they are now considering exploring the feasibility of a two-metre rise to the building. This solution, though expensive, may be the only viable long-term protection against future flood events.

FIGURE 6 - A STAFF MEMBER AT THE HOSPITALITY CLUB VENUE INDICATES THE APPROXIMATE PEAK OF THE 2025 FLOODWATERS ON THE FIRST-FLOOR BAR TAPS, OVER ONE METRE HIGHER THAN THE 2021 FLOOD LEVEL. VISIBLE ON THE BAR FRONT ARE PLAQUES MARKING PAST FLOOD HEIGHTS

- Staff and management are treating the current situation as an opportunity to rethink resilience strategies and to strengthen their operational continuity plans with plans to elevate the facility indicate a commitment to long-term resilience and risk reduction.

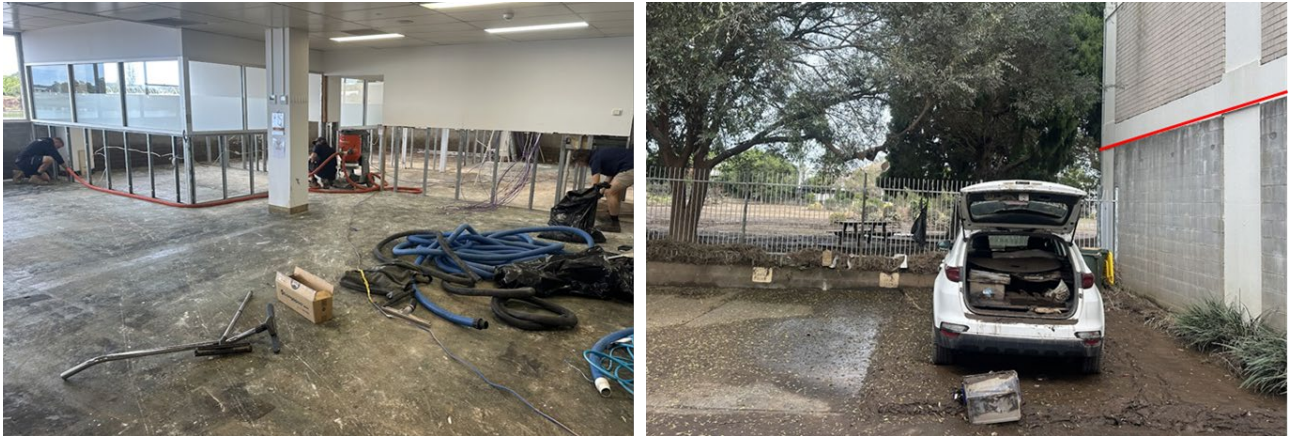
The rapid rise of the Manning River was a critical factor in the inability to safeguard assets. The nearby park saw at least 400 millimetres of sediment deposited. The building experienced inundation to a depth of approximately 1.2 metres (on the administration level) and is now undergoing moisture testing to assess structural and health safety for rehabilitation. Water levels on the basement level (at river level) exceeded 2 metres (Figure 7(b)).

FIGURE 7 - FROM L- R: (A) CLEAN-UP CREWS CONTINUE STRIP OUT OF THE ENTIRE FIRST FLOOR OF THE EDUCATION CAMPUS. (B) VEHICLE ABANDONED IN THE QUICKLY RISING FLOOD WATER WHICH REACHED APPROXIMATELY 3 METRES IN THESE LOCATIONS (RED LINE) IN THE CAR PARK OF THE CAMPUS ADJACENT TO THE MANNING RIVER (LEFT) AND CBD (RIGHT)

This case underscores the need for rapid impact forecasting and asset protection protocols, especially in shared service buildings. The experience also emphasises the vulnerability of newly occupied premises without tailored flood resilience plans.

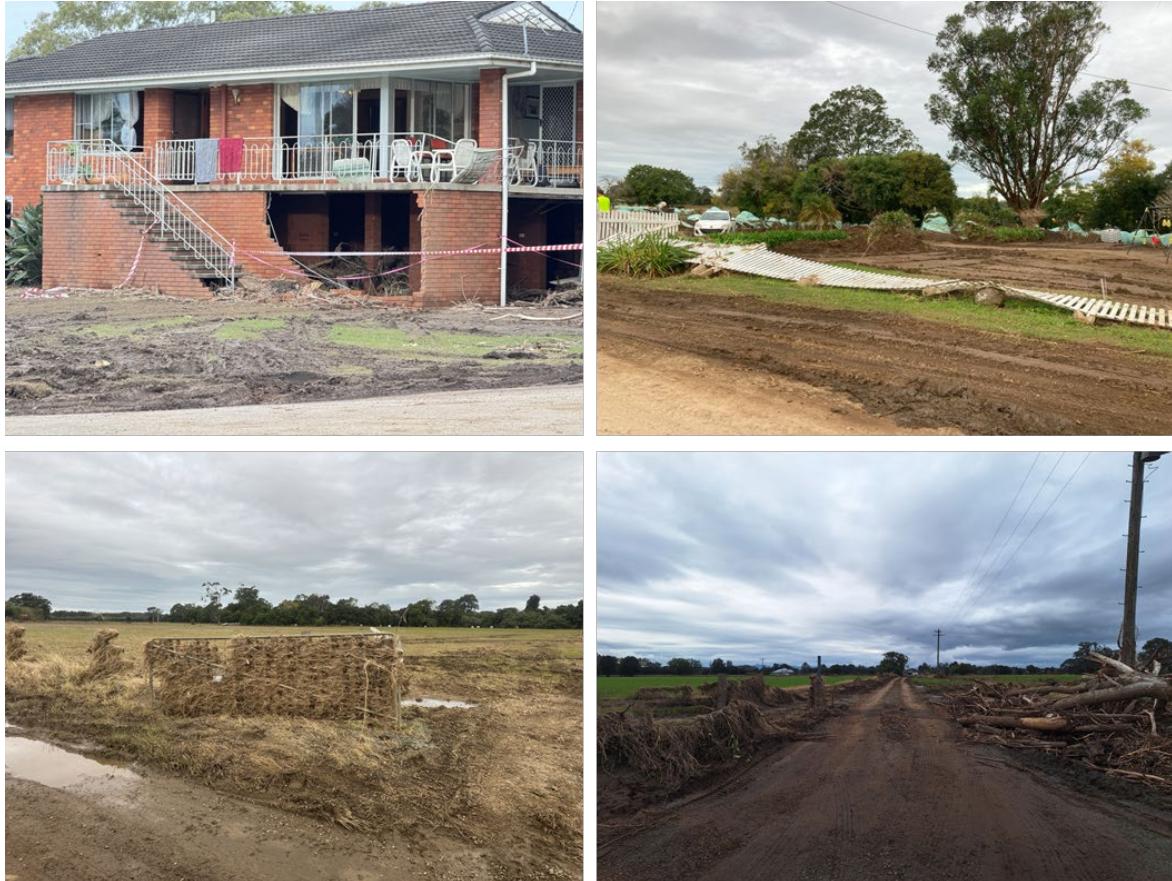
- Significant structural damage was observed, including wall collapses caused by floating debris such as logs and hay bales (Figure 8 (a)). Vehicles were swept from the roadways into nearby paddocks, fences collapsed, and hundreds of hay bales were scattered across the landscape (Figure 8 (b)), many torn apart by barbed wire fences or wedged against roadside barriers.
- Reports from impacted residents described delayed official evacuation notices, with some receiving alerts only after floodwaters had already rendered roads impassable. In some cases, emergency evacuations required window escapes into boats, highlighting critical gaps in early warning and response systems. Residents reported feeling terrified at the speed and height of the water which exceeded the gates and fences of paddocks (Figure 8 (d)).

FIGURE 8 - GLENTHORNE ON THE OPPOSITE (SOUTHERN) BANK OF THE MANNING RIVER FROM THE TAREE CBD WHERE VAST AMOUNTS OF VEGETATION, MOTOR VEHICLES AND FARMING DEBRIS WERE DEPOSITED. (CLOCKWISE FROM TOP LEFT) (A) WALL COLLAPSED FROM THE FORCE OF WATER AND DEBRIS (NOTE LOGS DEPOSITED INSIDE GROUND FLOOR) (B) FENCE TORN DOWN, VEHICLES WASHED INTO PADDOCKS AND HUNDREDS OF ROUND HAY BALES STREWN ACROSS THE LANDSCAPE, (C & D) HUGE LOGS AND GRASS DEBRIS ALONG ROADWAY AND AMASSED IN FENCING AND GATES AS AN INDICATION OF WATER HEIGHT AND FORCE

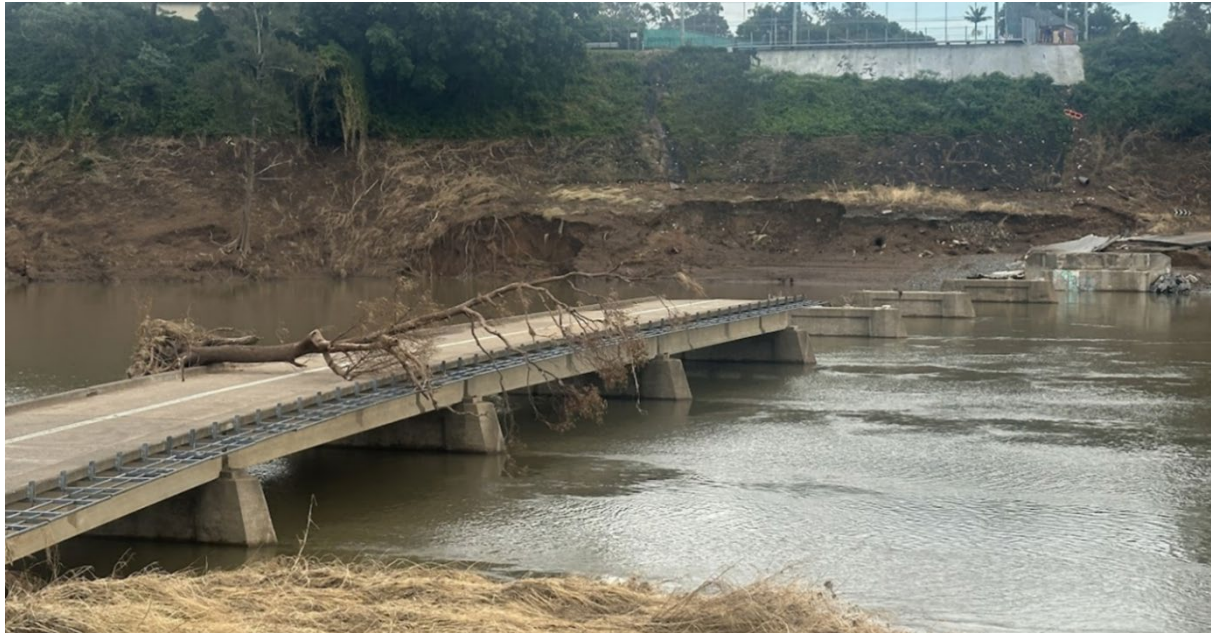
The Bight Bridge at Wingham sustained extensive damage, with over half of the structure washed away, resulting in significant disruption to travel and connectivity between Tinonee and Wingham (Figure 9). In addition to the bridge failure, the surrounding area exhibited severe riverbank erosion, providing stark visual evidence of the height and velocity of the floodwaters at this location.

FIGURE 9 - THE BIGHT BRIDGE LINKING WINGHAM WITH TINONEE REMAINS OUT AND IS PLANNED FOR REPLACEMENT. NOTE THE SIGNIFICANT BANK EROSION ON THE FAR BANK

- Mid Coast Council's website has confirmed that the bridge will receive at minimum a like-for-like replacement, funded through the Natural Disaster Recovery Arrangements. Restoration efforts will focus on re-establishing this vital transport link as part of the broader regional recovery².

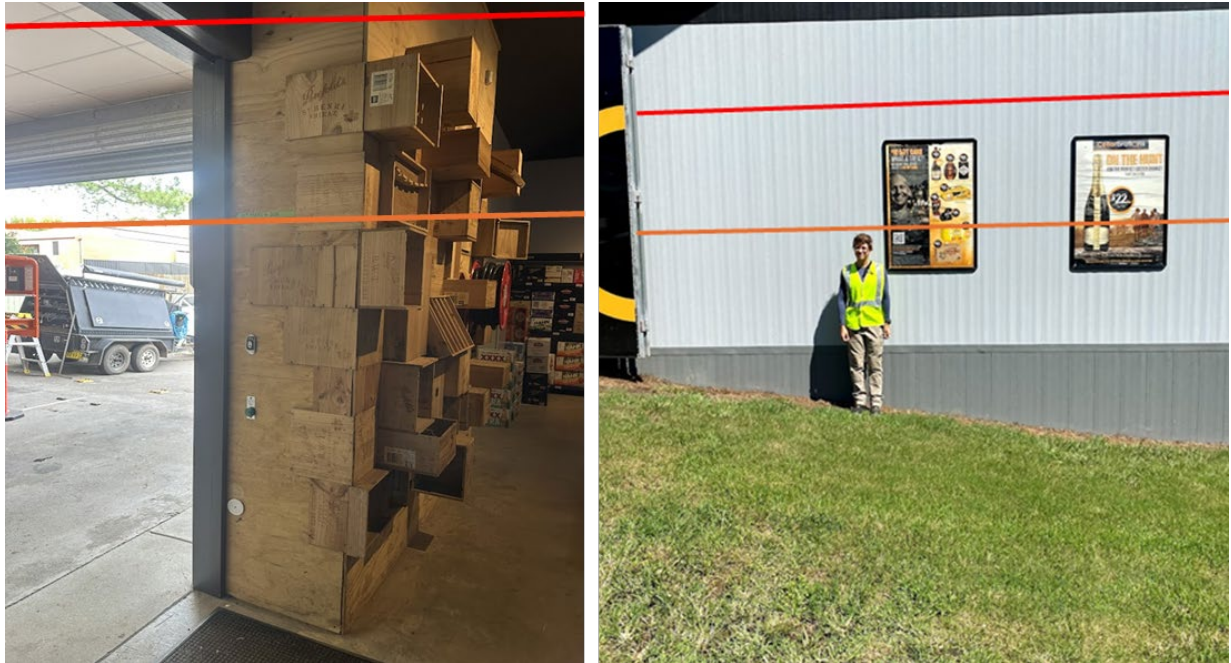
FIGURE 10 - THE BOTTLE SHOP IN WINGHAM WITH CONCRETE FLOOR AND REMOVABLE WINE BOX SHELVEING. ORANGE AND RED LINES INDICATE THE 2021 AND 2025 PEAK FLOOD HEIGHTS RESPECTIVELY BOTH INTERNALLY (LEFT) AND (EXTERNALLY) ON IMAGE TAKEN DURING THE 2021 DAMAGE SURVEY. DESPITE THE SIGNIFICANT DIFFERENCES IN FLOOD MAGNITUDE, INCREASED PREPAREDNESS BY THE OUTLETS OWNERS ENSURED THAT NO STOCK WAS LOST IN 2025 COMPARED TO OVER \$1 MILLION IN LOSSES IN 2021.

- This example reflects a shift in flood risk perception and showcases how informal, locally driven flood planning, especially in Taree, Wingham and Port Macquarie has matured due to prior exposure in 2021. By contrast, similar adaptive behaviours were less evident in Kempsey, which did not experience major flooding during that earlier event.

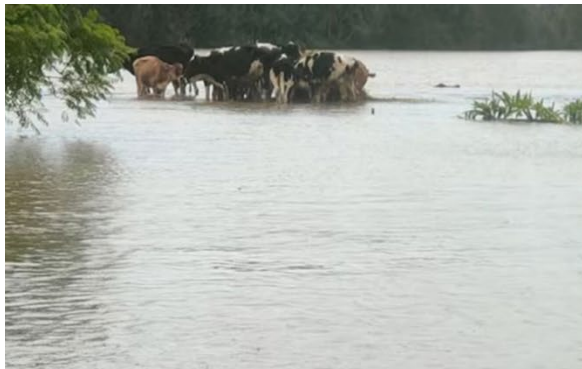
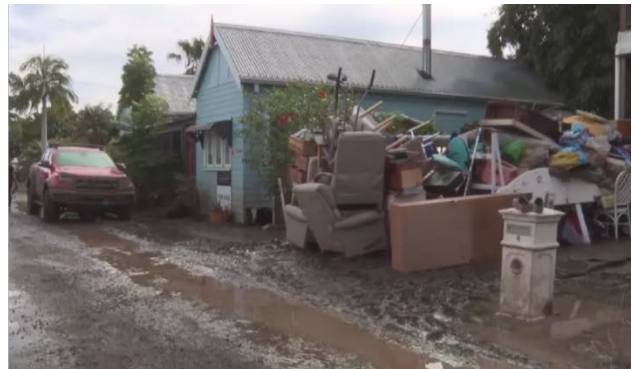
- Unprecedented flood levels - Residents described water heights as three times higher than any previously experienced, resulting in widespread damage to homes and properties.
- Agricultural losses - Dairy farms were hit particularly hard, with livestock stranded, pastures submerged and extensive damage to land and equipment. Farmers reported substantial financial losses due to destroyed crops and infrastructure.
- Infrastructure disruption - The area suffered from power outages caused by fallen trees, debris and flood-damaged electrical systems. Roads remained impassable during the field survey due to ongoing debris and mud clean-up.

FIGURE 11 - THE VILLAGE OF CROKI (L) CATTLE SHELTERING ON HIGHER GROUND AND IMAGE (R) THE TOWNSHIP OF CROKI WAS ALSO SEVERELY IMPACTED WITH MANY HOMES INUNDATED. IMAGE SOURCES: (L) ABC NEWS (R) BASTILLE POST GLOBAL⁴

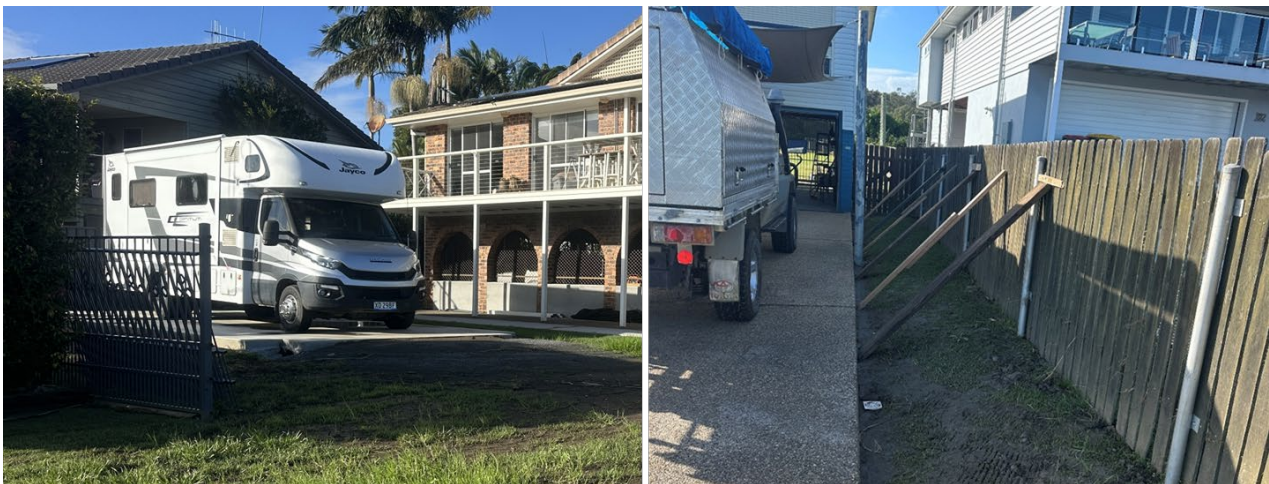
During the 2025 flood event, Settlement Point Drive in Port Macquarie was once again inundated, though to a lesser extent than in 2021. Water levels were approximately 250 millimetres lower than during the previous major flood, resulting in reduced physical damage but still significant disruption.

FIGURE 13 - EXPERIENCE WITH FLOODING IN 2021, THESE RESIDENTS ON SETTLEMENT POINT DRIVE IN PORT MACQUARIE HAVE INCREASED THEIR OWN PERSONAL RESILIENCE BY MAKING PREPARATIONS TO PROTECT PERSONAL PROPERTY. (IMAGE ON LEFT) - SHOWS A NEWLY CONSTRUCTED ELEVATED CONCRETE SLAB AND NEW MOTORHOME WHICH AVOIDED INUNDATION ON THIS OCCASION. (IMAGE ON RIGHT)-AFTER LOSING FENCES IN 2021, THIS RESIDENT HAS REINFORCED FENCES WITH TEMPORARY TIMBER BRACING AND GALVANISED STEEL POLES WITH CONCRETE FOOTINGS (IMAGE TAKEN FACING AWAY FROM RIVER)

- Impacted residents reported drawing lessons from the 2021 event, including monitoring local flood indicators such as river gauges and bridge inundations in the upper catchment, which they now use to anticipate local flood impacts more effectively.
- Residents have implemented both temporary and permanent protective upgrades, such as elevated concrete slabs and applied both permanent reinforcements (e.g. steel posts with concrete footings) and temporary (e.g. timber support struts) to fencing, to mitigate their destruction (Figures 13(a) and (b)).
- The 2025 event reflects a broader cultural shift toward individual preparedness, with growing acceptance of personal responsibility in managing flood risks among the local community.

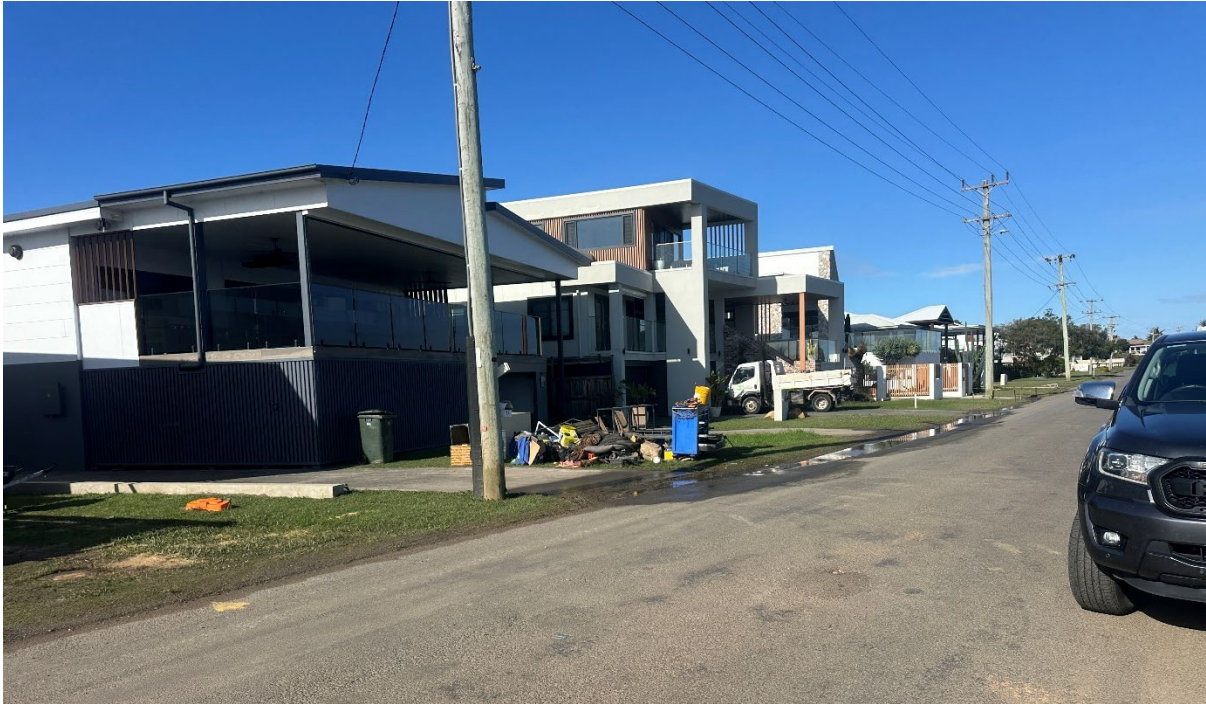
- One resident reported consistently securing flood insurance over a nine-year period, currently at a cost of approximately \$5,000 per year with Shannon's (underwritten by Suncorp). Following major impacts in 2021, they were able to file claims promptly and noted a timely response from the Suncorp insurance assessor. The house is constructed from concrete and raised, allowing water to pass through the ground (garage) level whilst the living areas are situated on the first floor (Figure 14).

FIGURE 14 - ONE OF ONLY SEVERAL HOUSES ON SETTLEMENT POINT DRIVE, PORT MACQUARIE WITH FLOOD INSURANCE COSTING ABOUT \$5000 PER YEAR. MOST HOUSES ON THE STREET ARE RAISED ON PIERS WITH LIVING AREAS LOCATED ON FIRST FLOOR AND GROUND FLOOR IS LARGELY A CONCRETE SHELL / GARAGE / STORAGE THAT ALLOWS WATERS TO PASS THROUGH

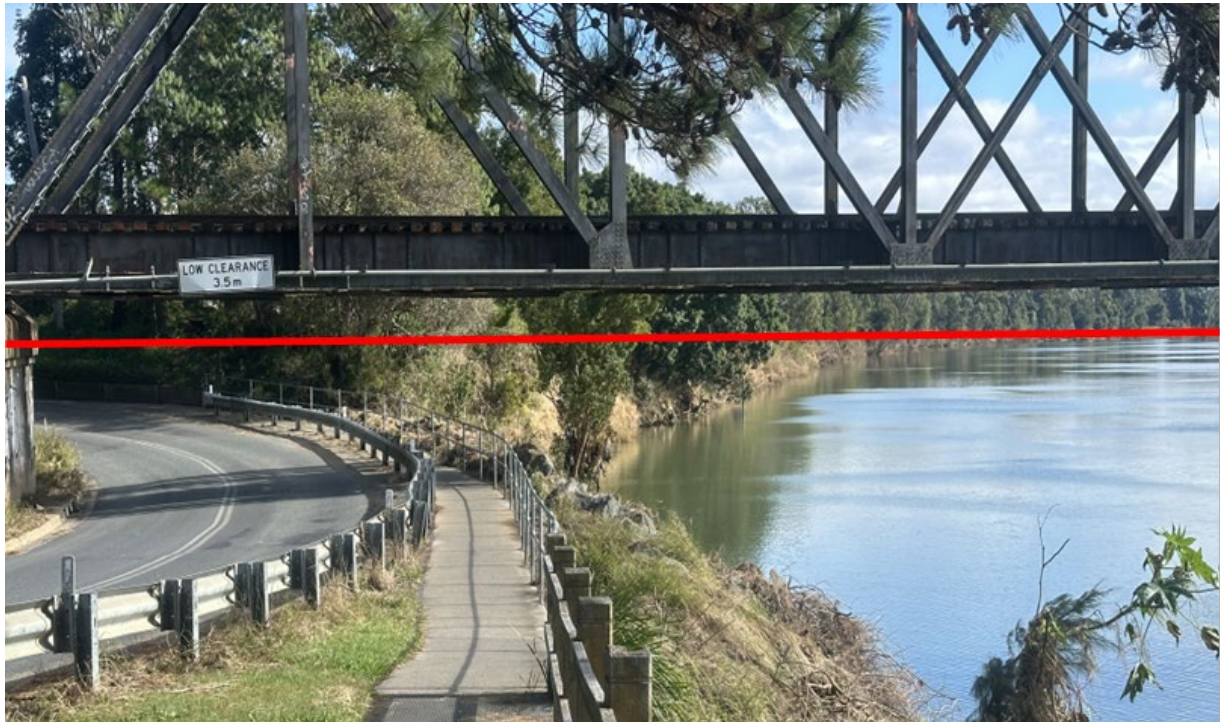
- At the Wauchope Railway Bridge, the Hastings River rose well above the major flood level of 5.50 metres, reaching 6.82 metres and potentially approaching seven metres at the peak of the event, as reported by Port Macquarie-Hastings Council (Figure 15). These levels significantly exceeded major flood thresholds and triggered emergency response measures.
- The flood particularly impacted low-lying areas adjacent to the Hastings River also experienced inundation. Flooding led to widespread road closures throughout Wauchope and surrounding low-lying areas, restricting movement and emergency access. Additionally, infrastructure such as beach areas at a nearby boat ramp at Rocks Ferry reserve were affected by bank erosion and flood damage including the total removal of the boating pontoon and ramp (Figures 16 (a) and (b)).

FIGURE 16 - THE RAILWAY BRIDGE AT WAUCHOPE SHOWING FLOOD HEIGHT (AS APPROXIMATED BY LOCAL RESIDENT)

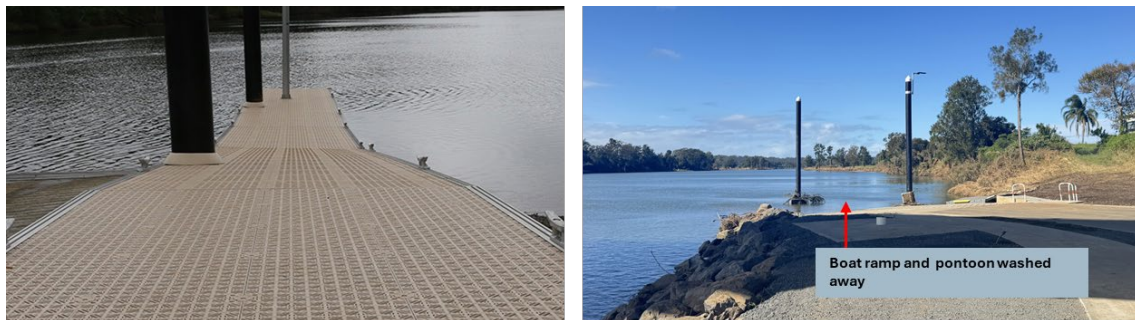
FIGURE 15 - FROM L-R, (L) THE BOAT RAMP AND PONTOON IN SITU AT THE ROCKS FERRY RESERVE PRIOR TO THE 2025 FLOOD (R) THE PONTOON AND RAMP WASHED AWAY

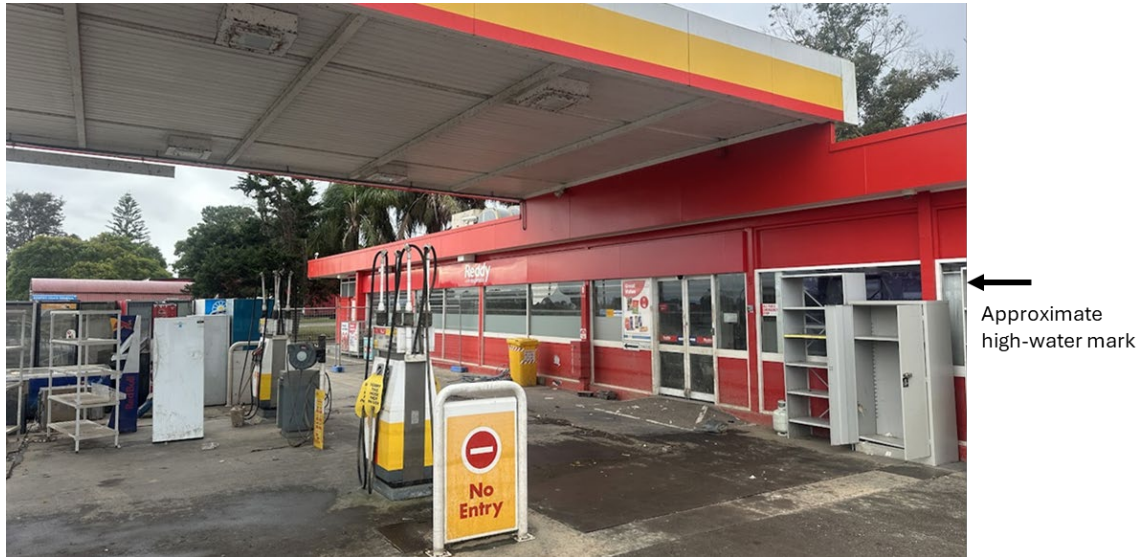
- Numerous businesses in the area remain closed due to extensive water damage. Many have not yet commenced clean-up or recovery efforts.
- An abandoned service station (Figure 19) remains cordoned off, with damaged fridges and freezers placed outside, awaiting removal near fuel bowsers.
- The shop interior has been completely stripped of all shelving and stock, indicating potential long-term closure.
- The motel next door to the service station was also severely inundated, with no signs of activity or management presence during the flood assessment.
- Water levels in the area suggest the business has likely ceased operations indefinitely.

FIGURE 18 - A SERVICE STATION IN WEST KEMPSEY REMAINS CLOSED WITH THE REMNANTS OF FUEL BOWSERS, FRIDGES AND FREEZERS DESTROYED IN THE FLOOD BEHIND TAPE. FLOOD LEVEL AT THIS LOCATION WAS > 2 METRES

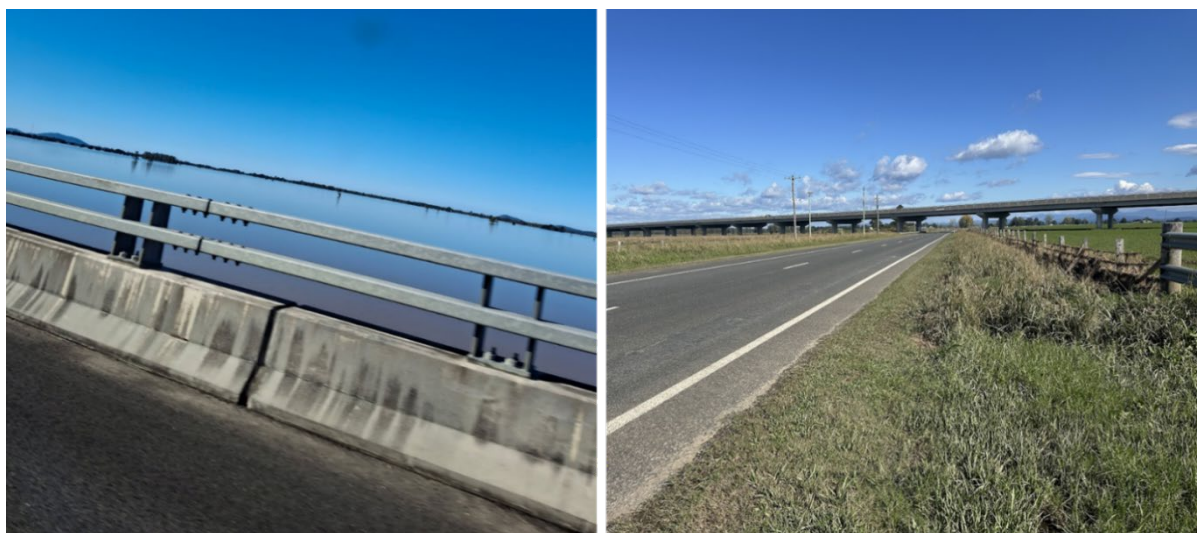
- Extensive flooding across the floodplains in the Pola Creek area, located beneath the elevated Pacific Highway, resulted in widespread property impacts. Many affected farmers are only now seeking assistance at local recovery centres, having prioritised initial clean-up efforts in the immediate aftermath of the event.

FIGURE 19 - POLA CREEK AREA BETWEEN KEMPSEY AND SMITHTOWN: (LEFT IMAGE-TAKEN BY PERSON KNOWN TO SURVEY TEAM) - TAKEN ON 24 MAY FROM THE ELEVATED SECTION OF THE PACIFIC HIGHWAY, SHOWS THE EXTENSIVE FLOODING ACROSS THE FLOODPLAIN BELOW, LOOKING IN THE DIRECTION OF KEMPSEY.(RIGHT) - THE SAME APPROXIMATE CAPTURED ON 4 JUNE FROM THE FLOODPLAIN ITSELF ON SOUTH WEST ROCKS ROAD, BENEATH THE PACIFIC HIGHWAY, DURING A SITE VISIT BY THE SURVEY TEAM.

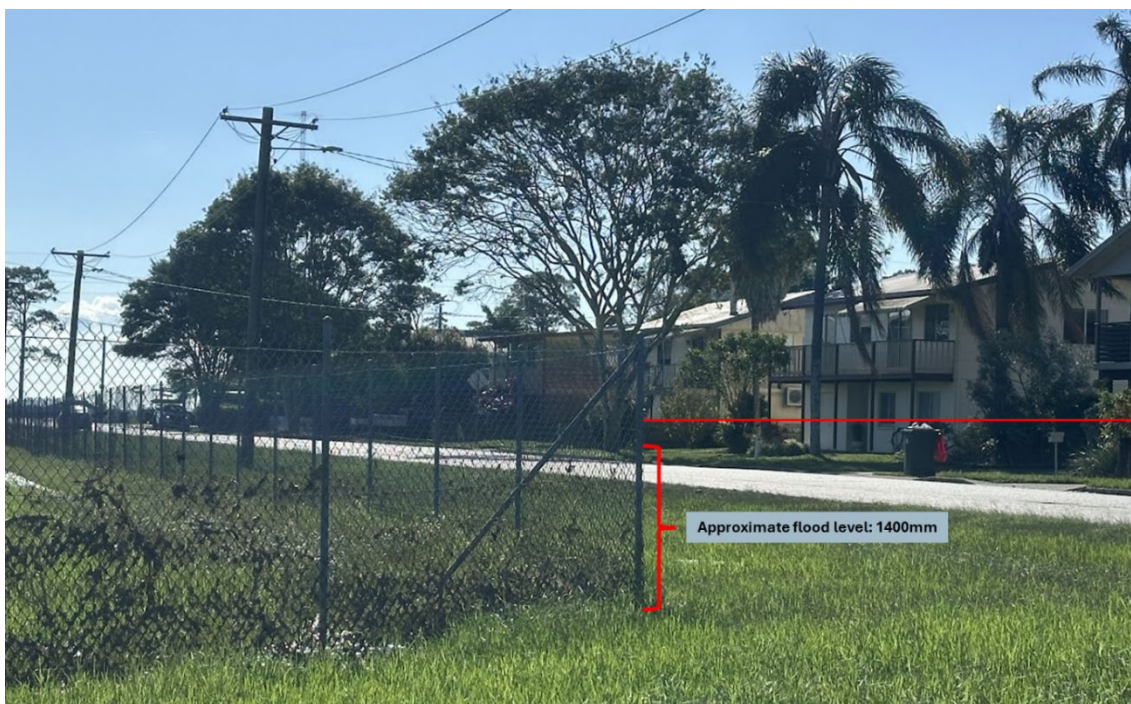
- Extensive debris fields and sediment deposition were observed across paddocks downstream of the township, indicating the high velocity and force of floodwaters moving through the area.

FIGURE 20 - RAWSON STREET AT SMITHTOWN SHOWING ABANDONED HOMES AND APPROXIMATE FLOOD HEIGHT OF 1400 MM (RED LINE) DETERMINED FROM FOOTBALL FIELD FENCE DEBRIS AND FLOOD WATER LINES ON HOMES
